## BEECH 18 INSPECTION PROCEDURES

This document applies to all Beech 18 series airplanes including military counterparts and other counterparts approved by Supplemental Type Certificates (STC's), regardless of the category or categories of airworthiness certification.

COMPLIANCE: Required as indicated. To prevent possible failure of wing structure, accomplish the following for the left and for the right sides of each affected airplane.

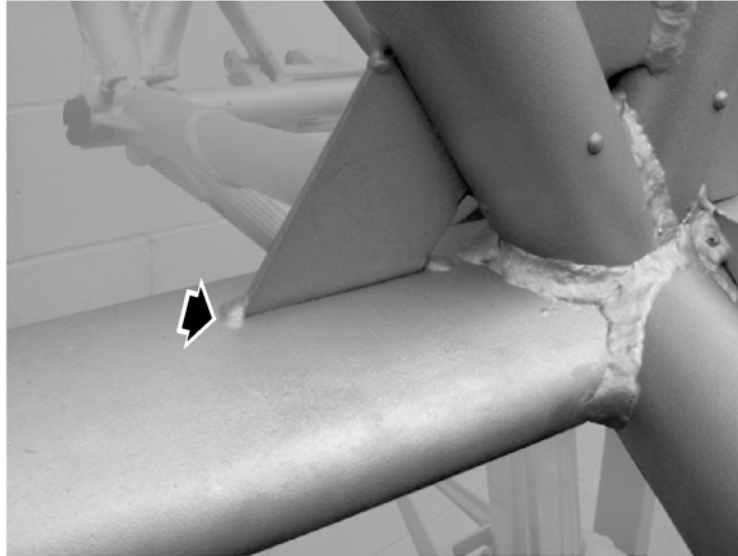
**Detail A - Typical Gusseted Joint**

TYPICAL GUSSETED WELD JOINT. ARROW INDICATES AREA OF SUSCEPTIBLE CRACKING AT TIP OF THE GUSSET WELD

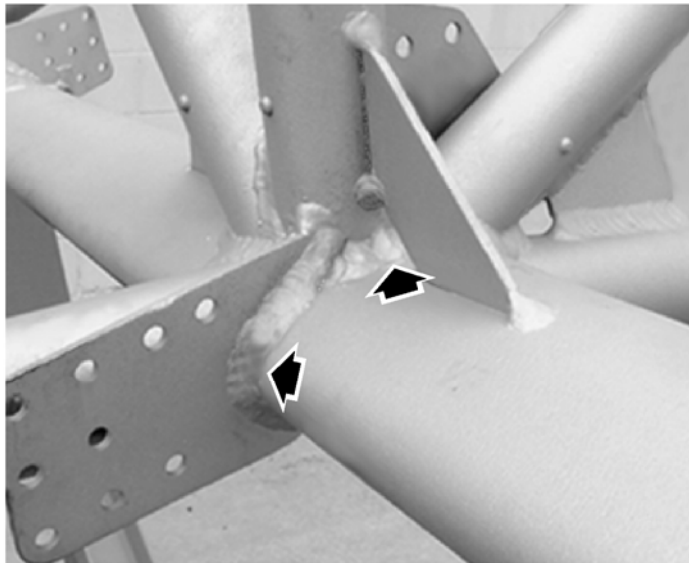
**Detail B - Typical Cluster (Plain) Joint**

VIEW OF CLUSTER WELD JOINT. ARROW INDICATES AREA OF SUSCEPTIBLE CRACK.

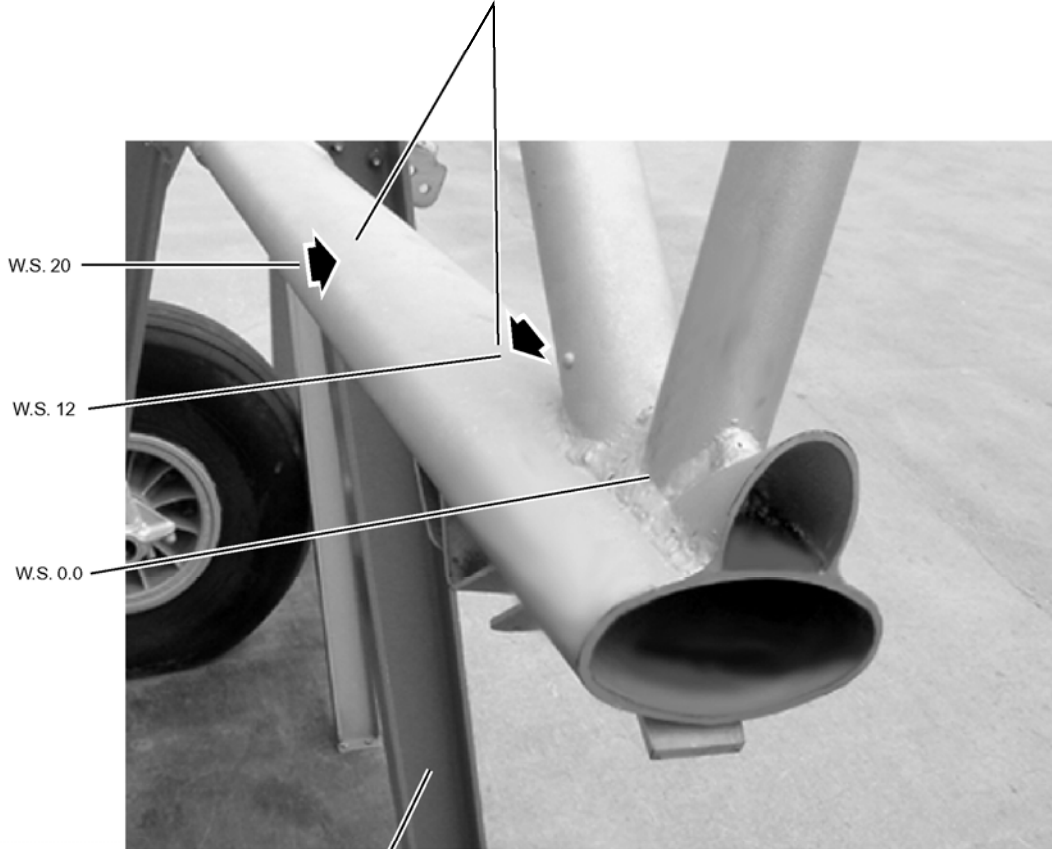
### Detail A – Lower Spar Tube Corrosion Inspection at W.S. 12 and W.S. 20

INSPECT FOR CORROSION OF THE LOWER SPAR TUBE AT W.S. 12 AND W.S. 20. INSPECT FOR INTERNAL CORROSION USING X-RAY (RADIOGRAPHIC) INSPECTION METHOD.

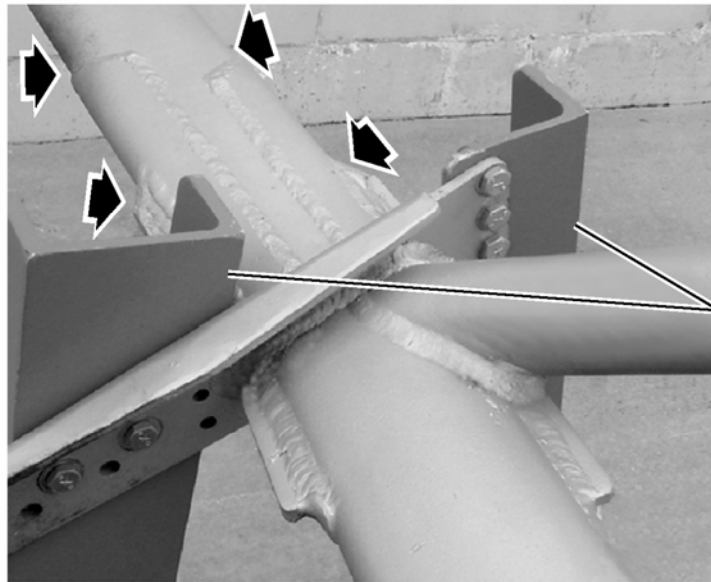
**Detail B – W.S. 28 Splice Plate and W.S. 32 Inspection Locations**

NOTE - THE W.S. 32 INSPECTION LOCATION NORMALLY USES A 0.25 INCH PENETRAMETER. IF A BEECH KIT IS WELDED TO THE SPAR CAP, USE A 0.37 INCH OR 0.50 INCH PENETRAMETER INSTEAD, DEPENDING ON TOTAL SPAR TUBE THICKNESS, INCLUDING THICKNESS OF REINFORCEMENT PLATES.

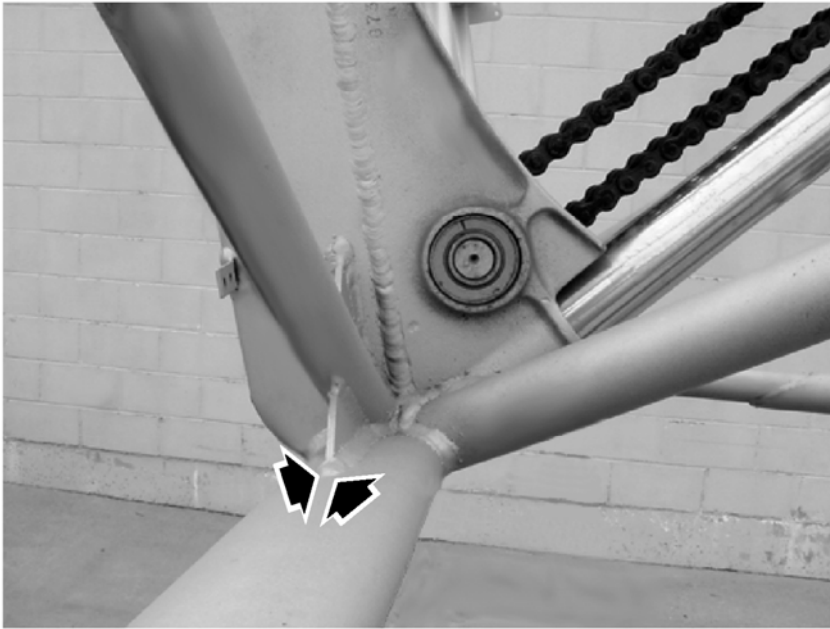
**Detail G – Gusset Weld Inspection Location at W.S. 73**

NOTE - IF A BEECH REINFORCEMENT KIT IS INSTALLED AT W.S. 81, USE A 0.50 INCH PENETRAMEETER IN LIEU OF THE 0.25 INCH PENETRAMEETER THAT IS NORMALLY USED IF A KIT IS NOT INSTALLED.

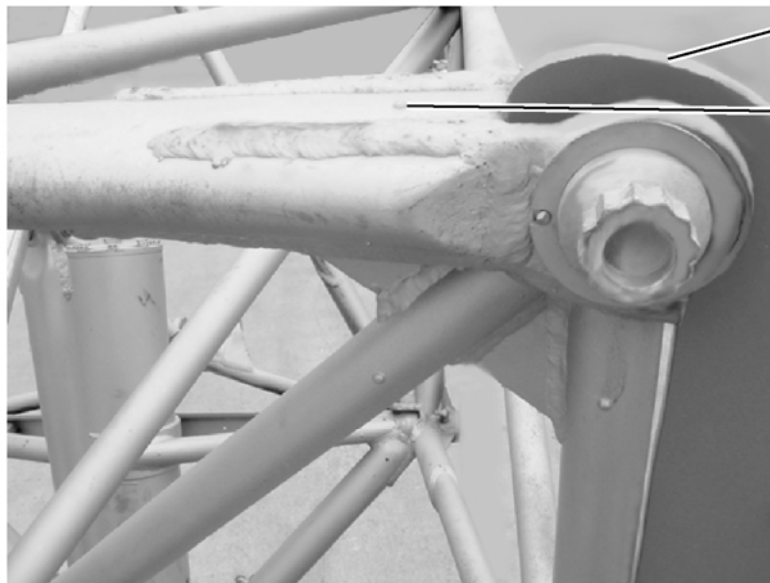
### **Detail I – Upper Inboard Wing Fitting**

NOTE - INSPECT FOR CORROSION ONLY

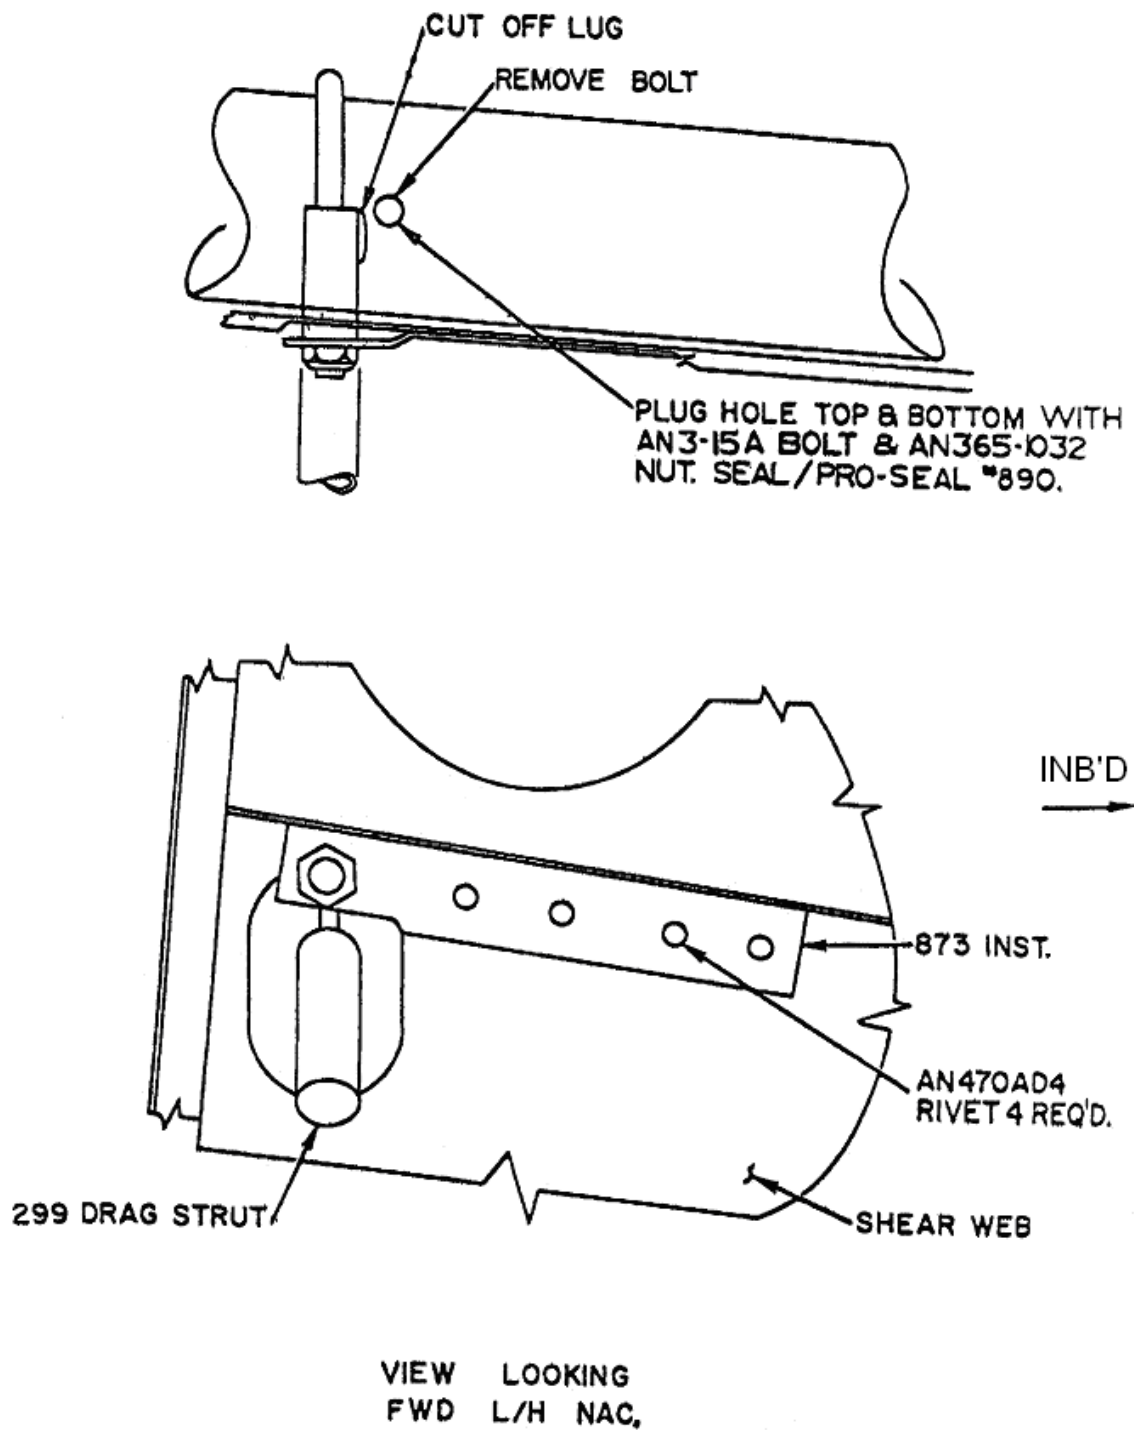
Figure 8 – Lower elliptical spar tube and 299-2 drag strut (W.S. 92)

Remove two AN3-17A bolts from the lower elliptical spar tube and the 299-2 drag strut at the point just inboard of the outer wing attach fitting. (See Figure 8)

Inspect the bolts for indications of corrosion and pitting and the edge of the bolt hole through the elliptical spar tube for indications of moisture and/or corrosion.

Remove the drive screw from the elliptical spar tube at a point just outboard of the side of the fuselage. Blow warm air (max 300°F) through the elliptical spar tube by introducing the air at the bolt hole in the spar tube in one nacelle and out at the other nacelle.

Seal all remaining bolts and attach points with Pro Seal Compound 890, or equivalent.

To prevent the recurrence of corrosion, treat the internal spar using Lear Chemical Corp. ACF-50 (MIL-C-81309) corrosion treatment, or equivalent per ACF-50 Procedure Methods Manual.
