## BEECH 18 INSPECTION PROCEDURES

This document applies to all Beech 18 series airplanes including military counterparts and other counterparts approved by Supplemental Type Certificates (STC's), regardless of the category or categories of airworthiness certification.

COMPLIANCE: Required as indicated. To prevent possible failure of wing structure, accomplish the following for the left and for the right sides of each affected airplane.

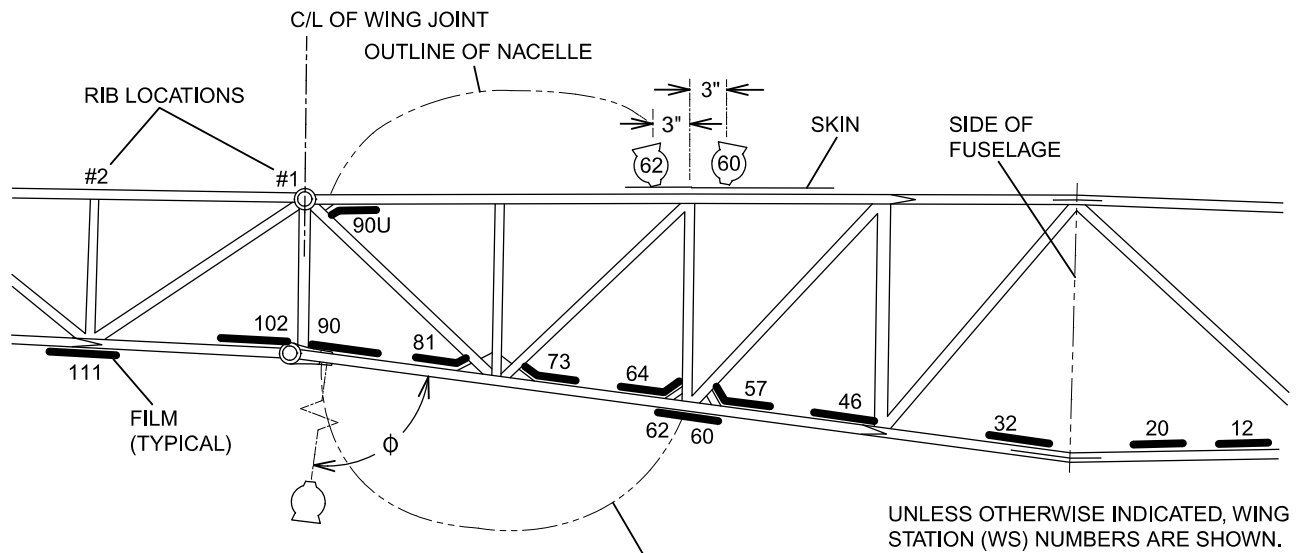
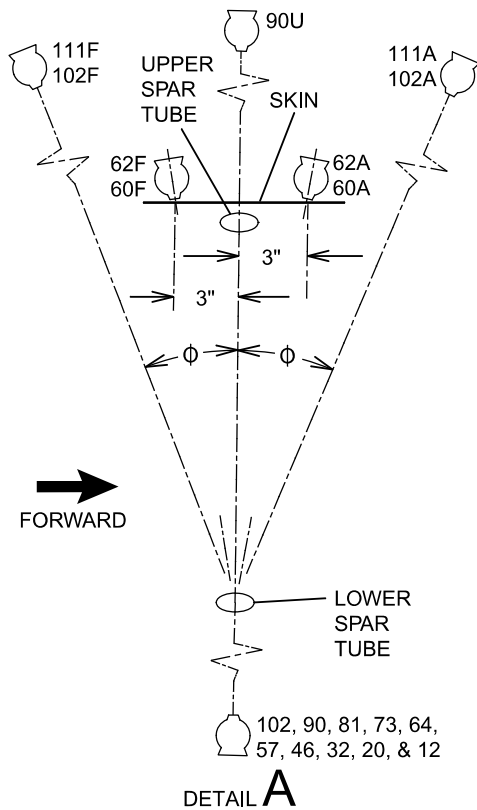
**Figure 3 Radiograph Film (X-Ray) Locations and Source Orientation/Aiming Angles**

UNLESS OTHERWISE INDICATED, WING STATION (WS) NUMBERS ARE SHOWN.

APPROXIMATELY 36" FILM-TO-SOURCE DISTANCE EXCEPT AS SHOWN AT 62 & 60

THE CHORDWISE AIMING ANGLE,  $\phi$ , IS BETWEEN PLANE OF SPAR AND X-RAY BEAM CENTERLINE. POSITION TAIL OF AIRPLANE AND/OR USE FIXTURE (AND CHECK WITH PROTRACTOR OR FLASHLIGHT) TO KEEP ANGLE  $\phi$  AT:

NOMINAL OF 0° (NO ABSOLUTE LIMIT) FOR WS 12, 20, 32, 46, 57, 64, 73, 81, 90, & 102. WS 102 MAY BE TAKEN WITH SOURCE EITHER ABOVE OR BELOW THE LOWER SPAR TUBE. WS 57 & 64 NEED NOT BE TAKEN SEPARATELY IF PLAINLY SHOWN BY WS 60 & 62 FILMS.

BETWEEN 20° AND 45° FOR FORWARD AND AFT SHOTS OF WS 111 & (OPTIONALLY) 102.

AS DRAWN FOR FORWARD & AFT SHOTS OF 60 & 62.

BETWEEN 80° AND 95° FOR WS 32, 46, 57, 64, 73, 81, 90, 102, AND 111.

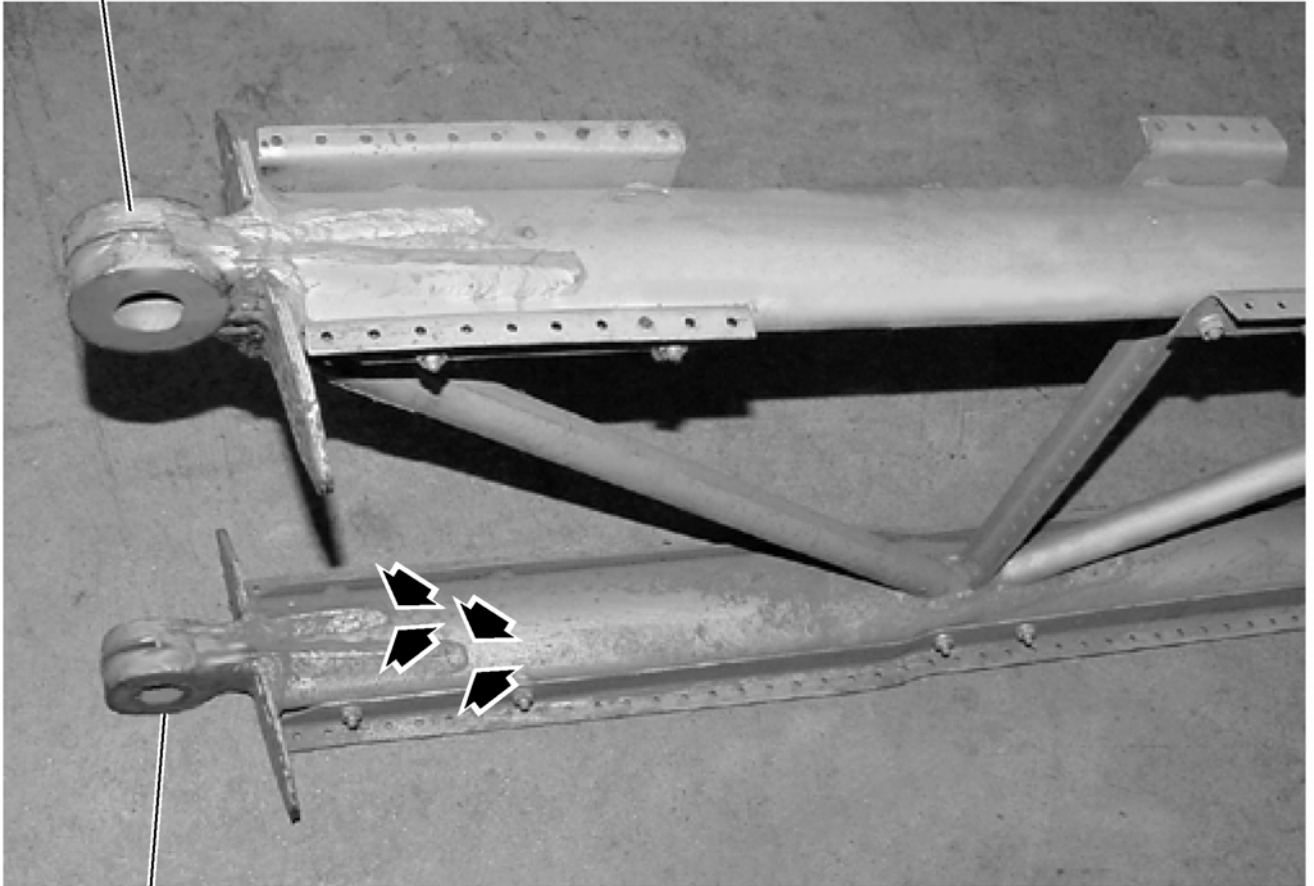
W.S. 102 WING ATTACH FITTINGS  
(RIGHT WING LOCATION SHOWN)

NOTE - W.S. 102 LOWER INSPECTION LOCATION DEPICTS A SHORT TANG WELDED TO THE LOWER, FORWARD LOCATION OF THE WING SPAR TRUSS TUBE, A LONG TANG IS SHOWN WELDED TO THE LOWER, AFT LOCATION OF THE OUTER WING SPAR TRUSS TUBE. WHEN VIEWING THE RADIOGRAPHS FOR THESE LOCATIONS, KEEP IN MIND THAT ON THE LOWER PORTION OF THE TUBE, THE LONG TANG IS WELDED AT THE LOWER, FORWARD LOCATION, WHILE THE SHORT TANG IS WELDED TO THE LOWER, AFT LOCATION. WHEN INSPECTING THE RADIOGRAPHS (X-RAY IMAGE NEGATIVES), LONG TANGS WILL BE SUPERIMPOSED OVER THE SHORT TANGS. PAY PARTICULAR ATTENTION TO THE ENDS OF EACH LONG TANG AND A LOCATION APPROXIMATELY ONE INCH INBOARD, WHICH IS THE END OF THE SHORT TANGS. CRACKING MAY PROPOGATE FROM THE ENDS OF ANY OF THESE WELD LOCATIONS. W.S. 102 UPPER LOCATION DOES NOT REQUIRE INSPECTION.

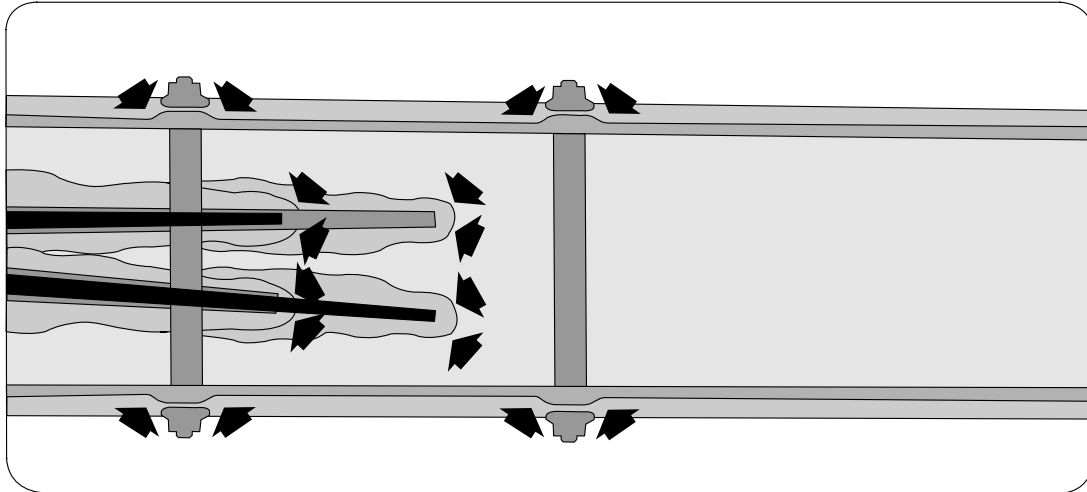
### Typical Radiographic Image for Lower W.S. 102 Inspection Location

**NOTE:** Figure 3 shows a forward and aft X-ray image of W.S. 102. If the areas of interest can be adequately shown by a single perpendicular X-ray image, as illustrated above, that single X-ray image is acceptable.

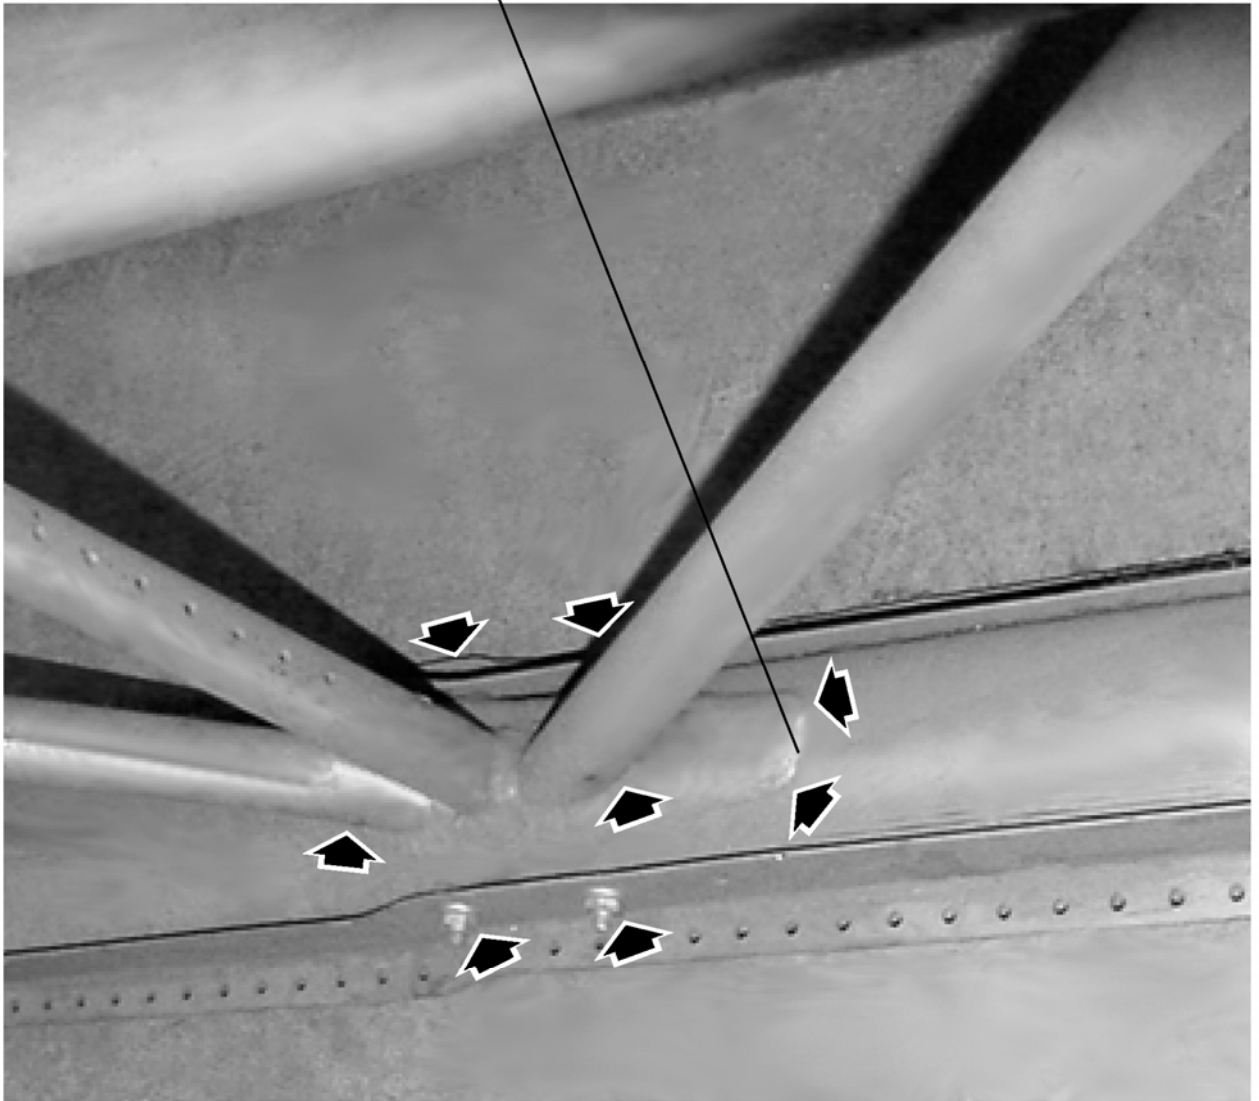
**Figure 5 (Sheet 3) – W.S. 111 (Forward and Aft) Fishmouth Weld and Through-Bolt Inspection Locations**

NOTE - WHEN VIEWING W.S. 111 LOCATION, TWO ENDS OF THE FISHMOUTH WELD SHOULD BE IN THE IMAGE AREA, THE UPPER AND LOWER FISHMOUTH. BOTH SHOULD BE INSPECTED.  
NOTE - IF A BEECH KIT IS WELDED TO THE SPAR CAP WHERE A 0.25 INCH PENETRAMETER IS SPECIFIED, USE A 0.37 INCH PENETRAMETER INSTEAD.  
NOTE - BOTH SIDES OF WELDS AT BOTH FORWARD AND AFT ENDS OF THROUGH BOLTS ARE INSPECTED.

END OF FISHMOUTH  
WELD AT W.S. 111

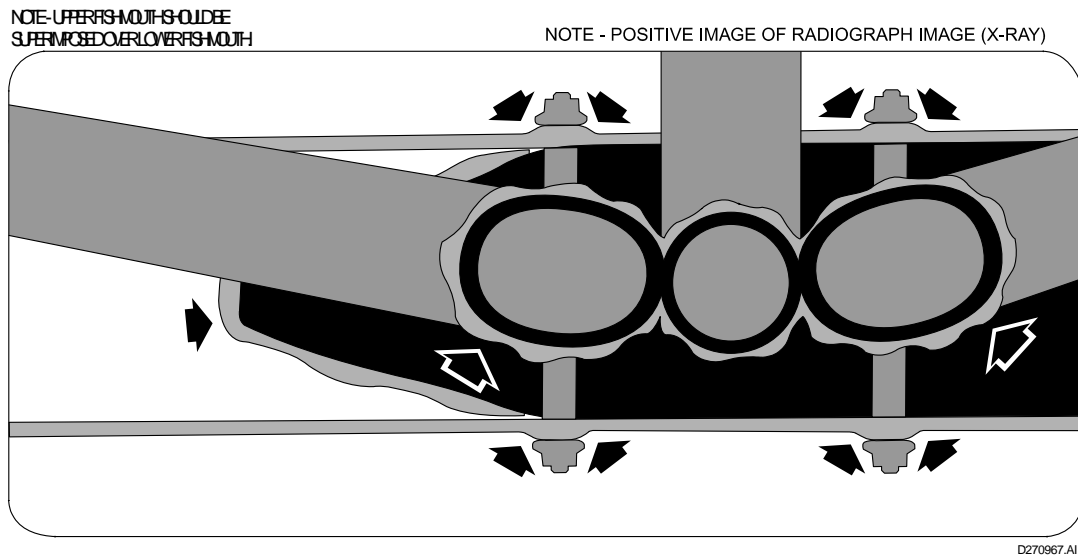
**Figure 5 (Sheet 4) – Radiographic Image of W.S. 111 (Forward and Aft) Fishmouth Weld and Through-Bolt Inspection Locations**

**NOTE: W.S. 111 must be X-rayed from both forward and aft angles as shown by Figure 3.**
